**RB FALCON
DEEPWATER HORIZON
BOP ASSURANCE ANALYSIS**

Deepwater Horizon BOP Assurance

WS ATKINS INC

Report No: CL4148-001/FMECA (REV 2)
Issue Date: March 2001

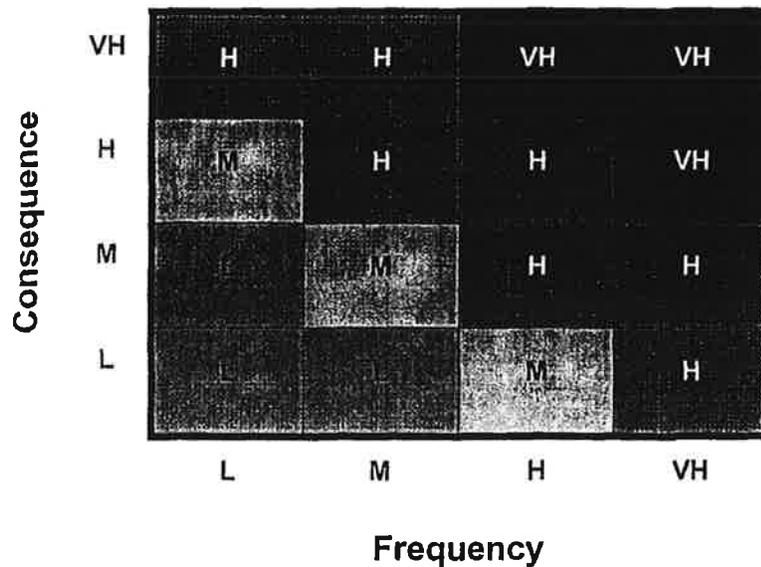
Figure 3.1: Criticality Matrix

The criticality analyses for each failure mode is determined by its placement within the matrix based on the frequency and consequence ratings. The matrix is presented in Figure 3.1. The most critical failure modes are represented by a "VH" (very high) in the upper right corner of the matrix, while the least critical failure modes will have an "L" (low) in the lower left corner of the matrix.

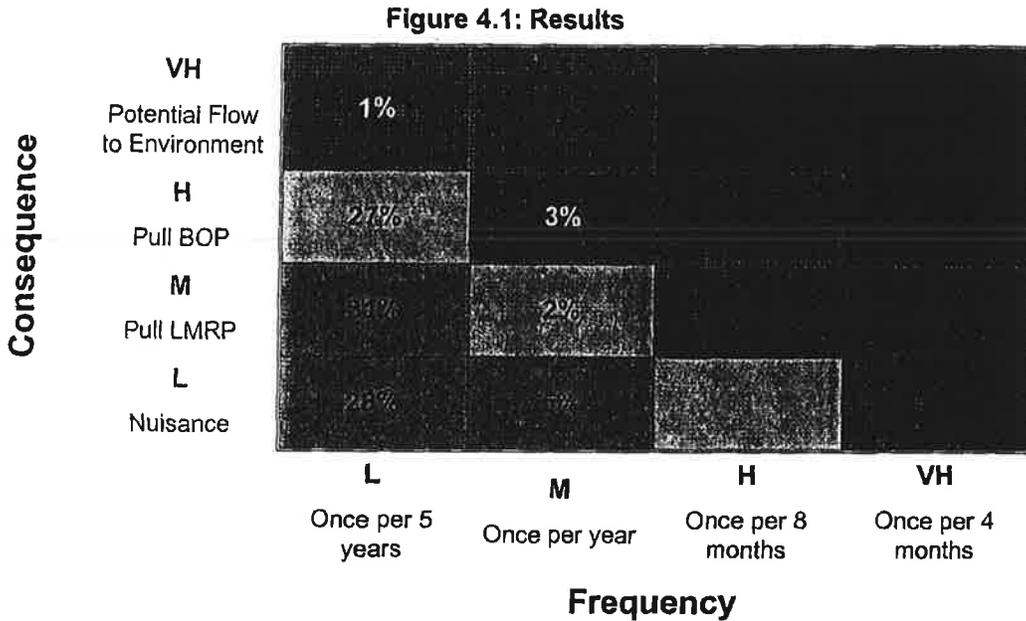
The results of the analysis are detailed in this section of the report. Figure 4.1 details the results of the FMECA. The table shows the percentage of the total failures identified associated with each location in the risk matrix. A total of 260 failure modes were identified during the analysis.

Color	Category	% of Failure Modes in Category
	Very High Risk	0%
	High Risk	4%
	Moderate Risk	29%
	Low Risk	64%

Note: 4% of the failures identified were not ranked. These failures were not ranked because they did not represent new issues that required ranking.

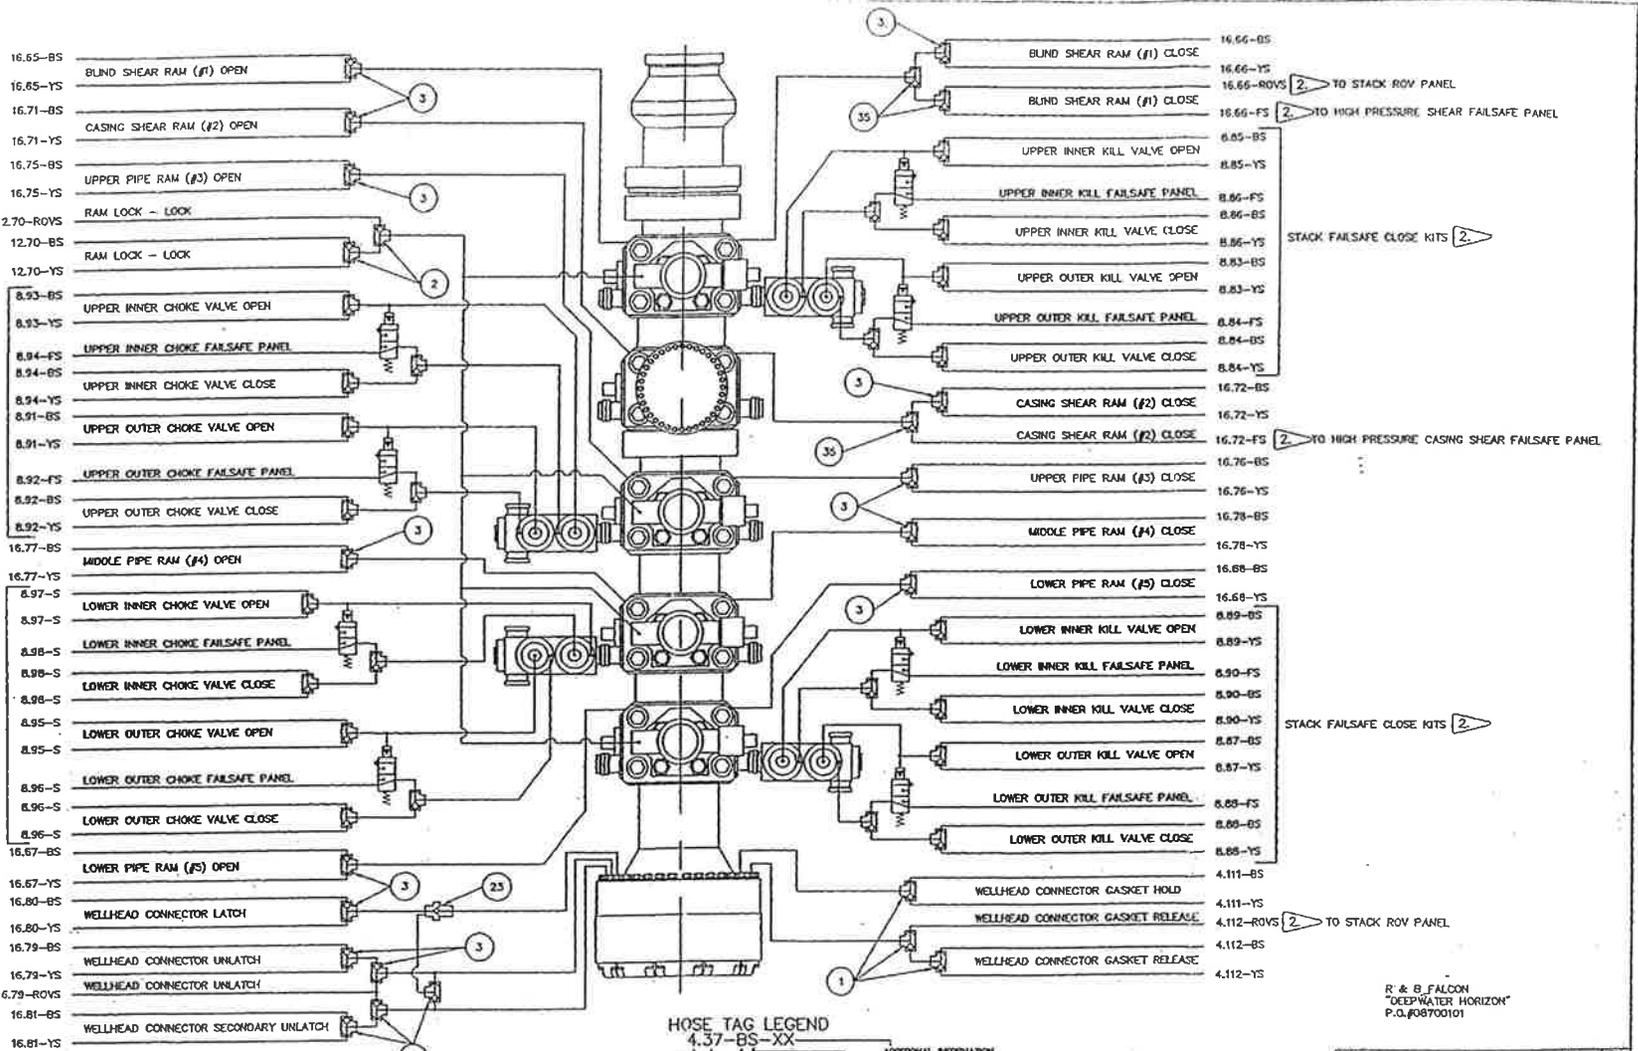
REV. BY: R. Schukla		DATE: 05/11/00	
REV. NO. 1		REV. NO. 001	
		CAMERON CONTROLS COMPANY HEADQUARTERS P.O. BOX 1000 MARYLAND, WY 82401-1000	
TITLE: ASSEMBLY, STACK HOSE DIAGRAM DEEPWATER HORIZON		SHEET: 2 OF 4 DRAWING NUMBER: SK-122100-21-05	
PROJECT: 2020724-21		SCALE: 1:1

2 TO STACK ROV PANEL

2 STACK FAILSAFE CLOSE KITS
